The influence of high strength electric actuators on the turbocharger

Student: Martijn Boekhoorn

Bedrijf: Mitsubishi Turbocharger and Engine Europe B.V. (MTEE)

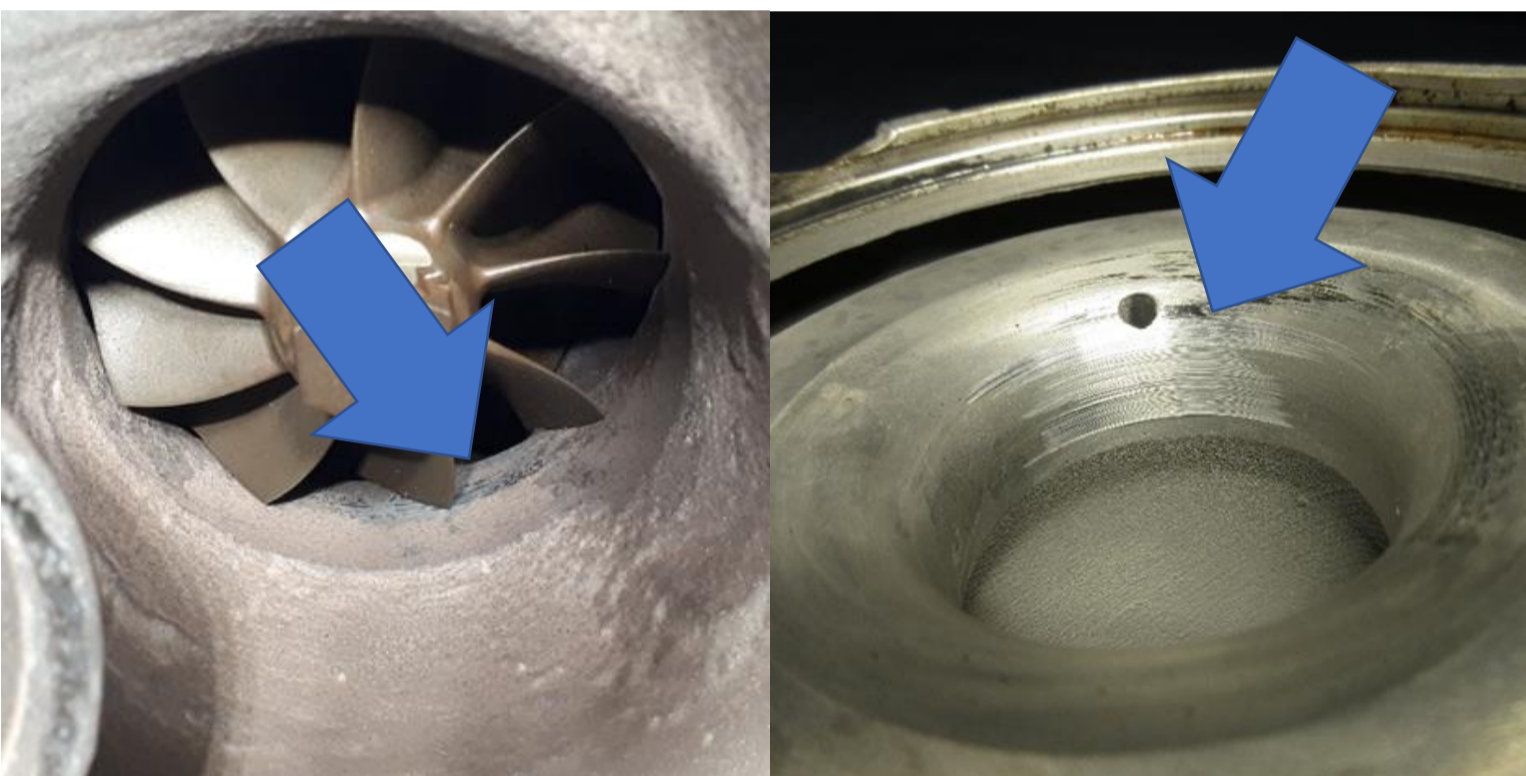
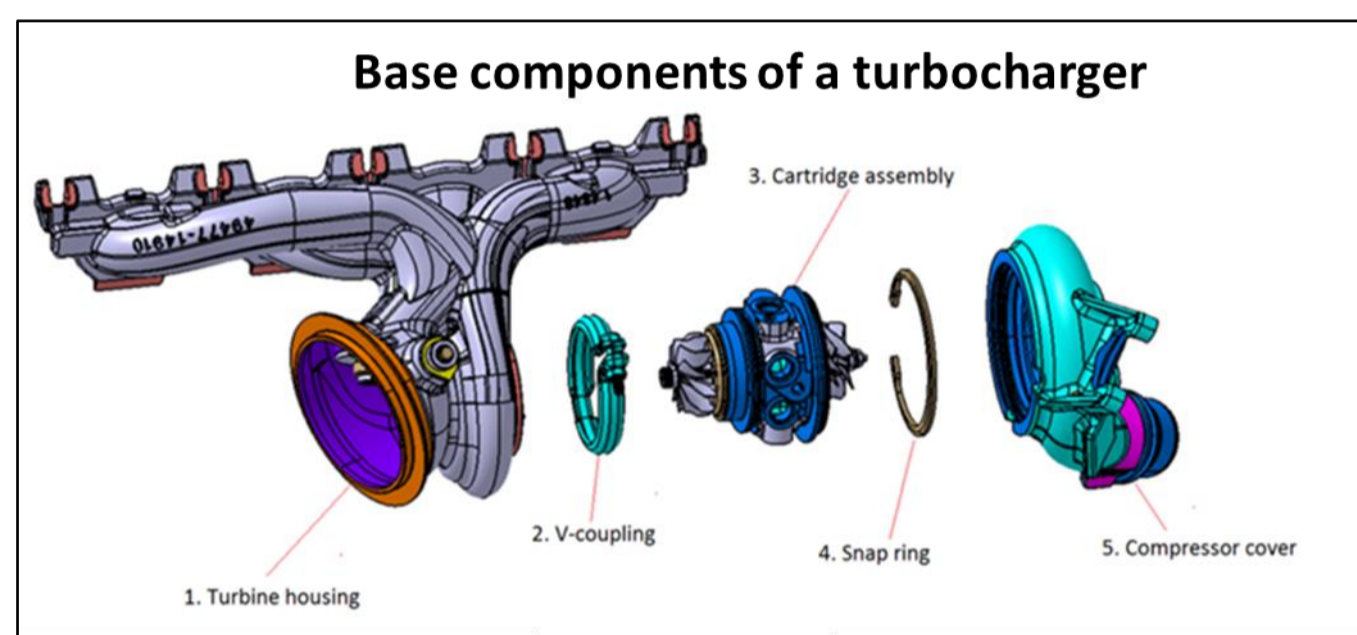
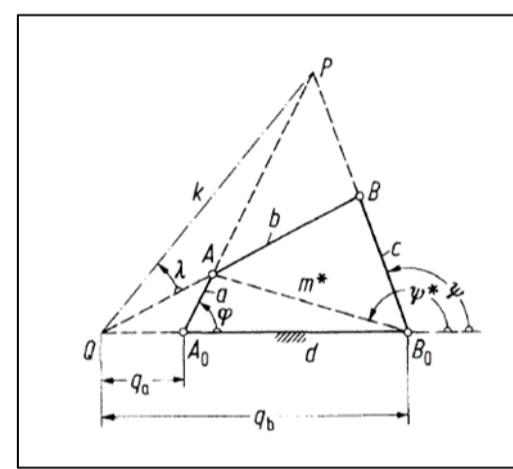
Failure in the form of contact between the wheels and their housings

It was determined that hitting was plausible.

However the damage pattern observed at the start of the project does not overlap with the damage pattern that was suggested by the results, the influence of the actuator is dubious

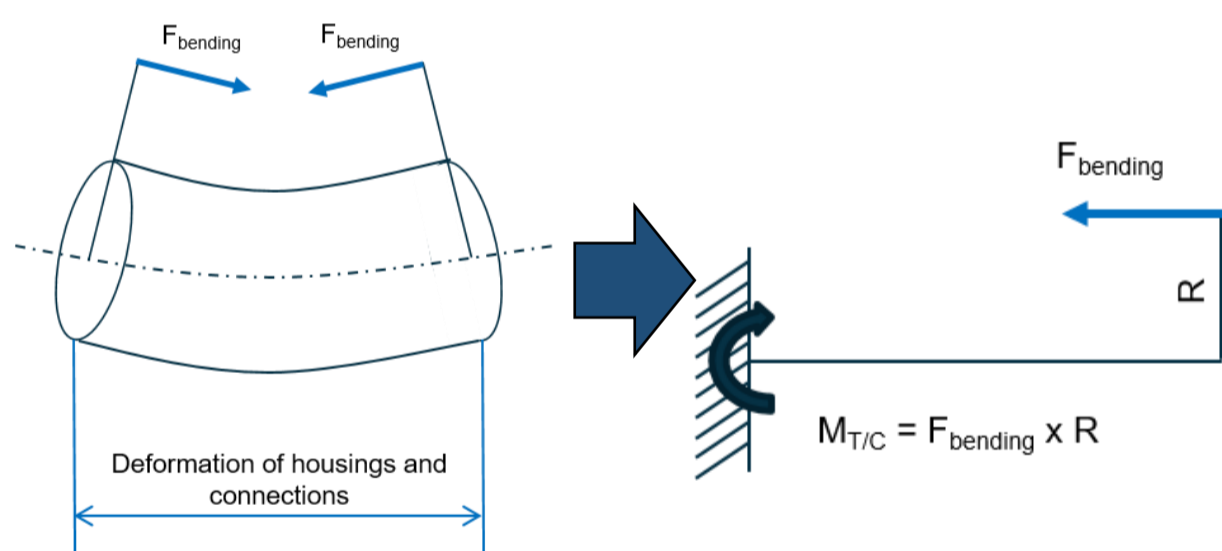
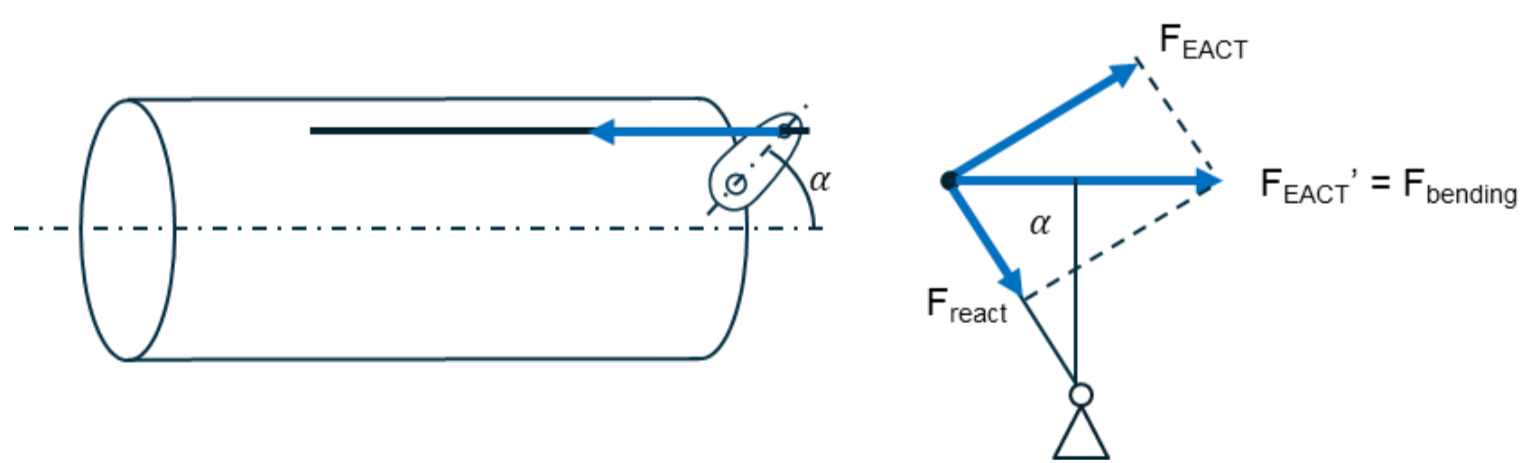
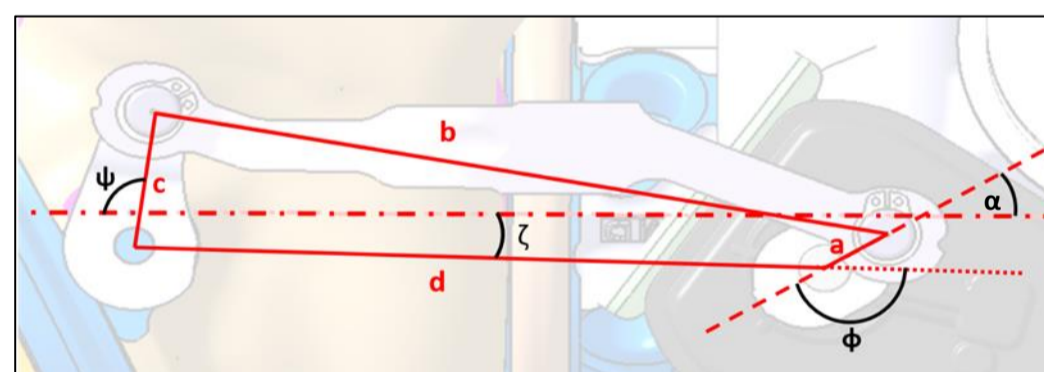
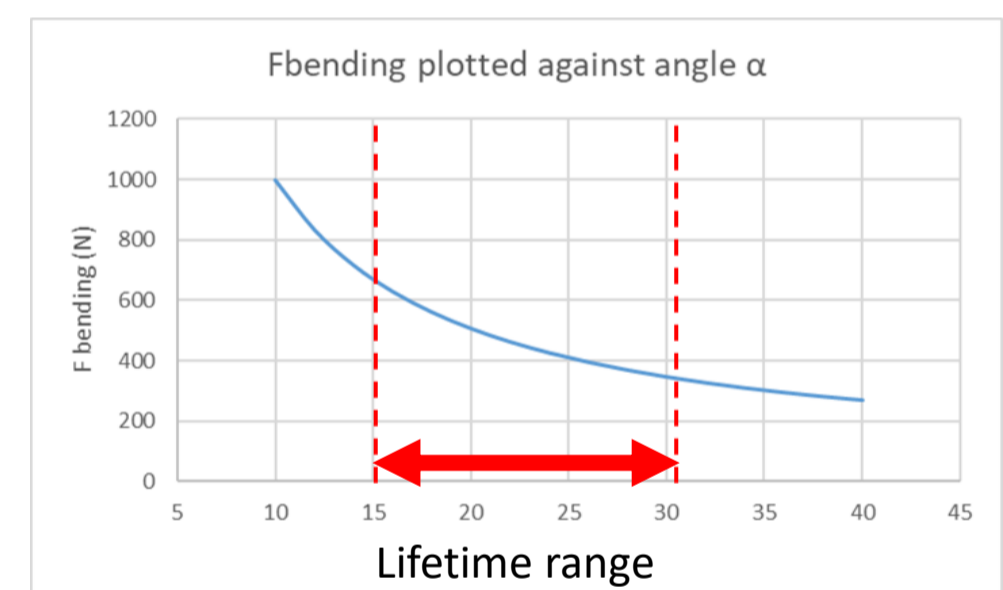
α is the most influential parameter, force in linkage system may double during turbocharger lifetime (below)
Use four bar linkage model to predict alpha during operation, several parameters change as a result of turbocharger use and lifetime (left)
Calculated $F_{bending}$ was used as input for housing deformation simulation
